# ***Bath Charter Township Newsletter June 2017***

## **Emergency Sewer Repair**

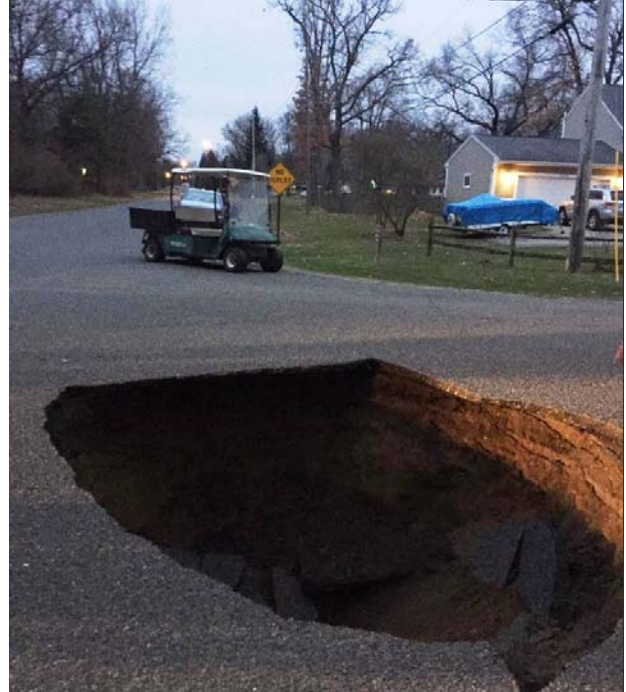
On the evening of March 27, the sanitary sewer main collapsed near the intersection of Gary Lane and Ann Drive, causing a sink hole. Southern Clinton County Municipal Utilities Authority (SCCMUA) was soon on site and reported the occurrence. Under our emergency purchasing policy, we contracted with Leavitt & Starck Excavating, who was on site the next morning.

March 27 sewer collapse near Gary Lane and Ann Drive. Emergency repairs such as this can be expensive. Photo from Facebook; photographer unknown.

And the immediate fix turned out to be “more a patch than a repair.” The permanent repair required cured in place pipelining (CIPP) to provide structural strength. Liquiforce was hired to install the CIPP, which was completed the first week of June.

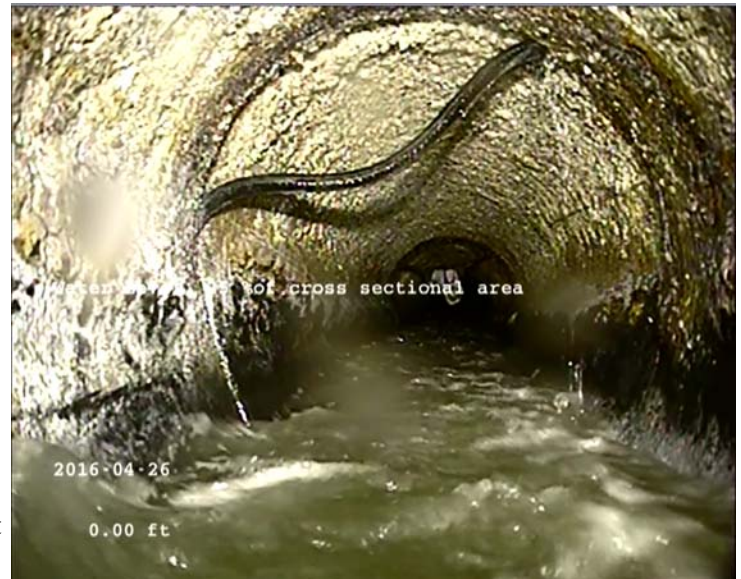
The main sewer interceptor was constructed in the early 1970s. And the concrete in the pipe is susceptible to corrosion from sulfides generated by the wastewater. Over decades, the corrosion has severely deteriorated much of this pipe.

SAW Grant Sewer Video: This photo is from televising the sewer in April 2016 at the location of the emergency repair. It shows the sulfide corrosion on the inside of the concrete sewer interceptor. The thick black item in the center is a rubber gasket between two sections of the concrete pipe; the pipe sections have been corroded away to the point that the gasket is falling in. With the gasket missing, ground water infiltrates the pipe. And the ground water carries grains of sand and sediment. Over time, more sand and more dirt create an empty pocket or void outside the pipe. When this void increases in size, it can collapse causing a sink hole in the road above and breaking the pipe below. The photo also shows a "shelf" on the sides of the pipe where the pipe has corroded above the waterline.

CIPP is a method of adding a plastic liner insides the existing sewer main. It essentially creates a brand new pipe inside the existing pipe. The new pipe provides structural integrity, is resistant to sulfide corrosion, reduces groundwater infiltration, and has an estimated life of seventy-five years. It is installed via existing manholes, so excavation is not needed. As a rule of thumb, CIPP is about half the cost of excavating and replacing a main (and much less expensive than an emergency repair).

Based on the SAW televising, we have identified two distinct areas of the sewer interceptor as high importance for CIPP this summer/fall. The engineering firm Prein & Newhof has been hired to assist with putting the work out for bids. This is a major sewer main, and these two projects will prevent another expensive emergency repair in the future.

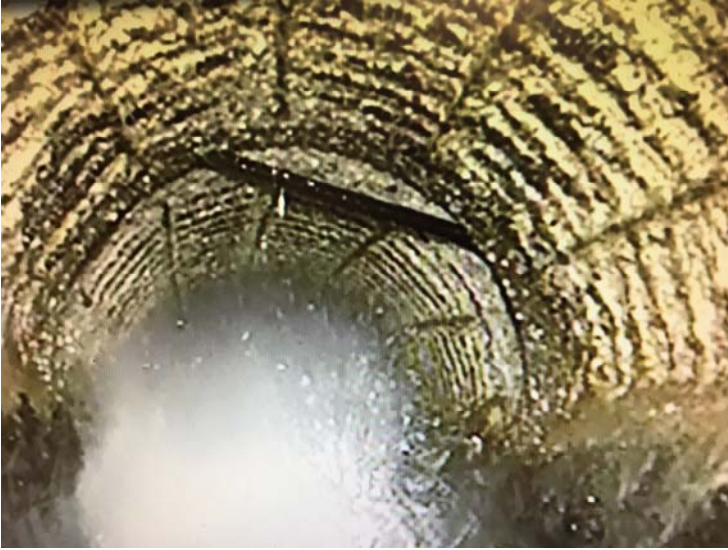
SAW Grant Sewer Video: This photo is from televising the sewer interceptor in April 2016. The grid pattern is the rebar support cage that is built into the concrete pipe. Since it is exposed, it means that the pipe has been corroded half-way through. This photo also shows a gasket beginning to fall out of place between two sections of the concrete pipe and a shelf at the waterline on the sides.
