Bath Charter Township Newsletter June 2017

Emergency Sewer Repair

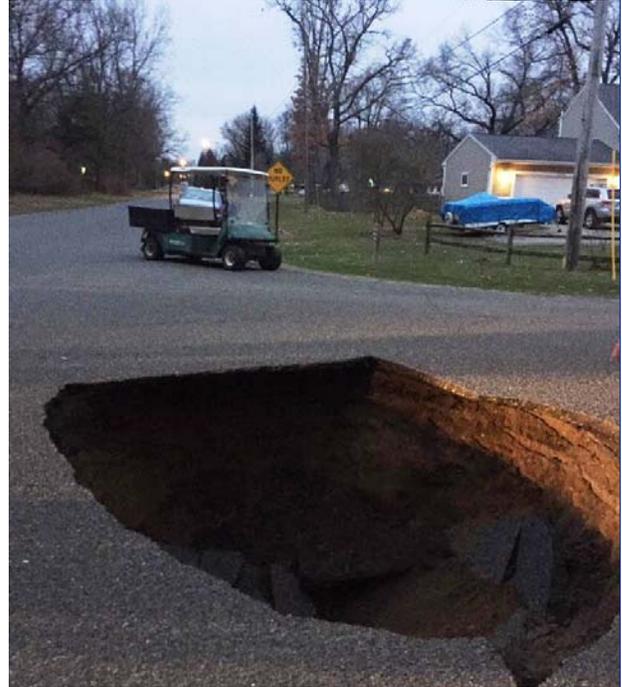
On the evening of March 27, the sanitary sewer main collapsed near the intersection of Gary Lane and Ann Drive, causing a sink hole. Southern Clinton County Municipal Utilities Authority (SCCMUA) was soon on site and reported the occurrence. Under our emergency purchasing policy, we contracted with Leavitt & Starck Excavating, who was on site the next morning.

March 27 sewer collapse near Gary Lane and Ann Drive. Emergency repairs such as this can be expensive. Photo from Facebook; photographer unknown.

This was a dynamic project, and its scope evolved as the work progressed. The ground water and soils were evaluated and determined that extensive dewatering of the site was necessary to avoid additional collapse during the repair and, in turn, to protect life safety and surrounding infrastructure and property. Two temporary wells were drilled to dewater the site before excavation could be completed, which added time and cost to the project.

And the immediate fix turned out to be “more a patch than a repair.” The permanent repair required cured in place pipelining (CIPP) to provide structural strength. Liquiforce was hired to install the CIPP, which was completed the first week of June.

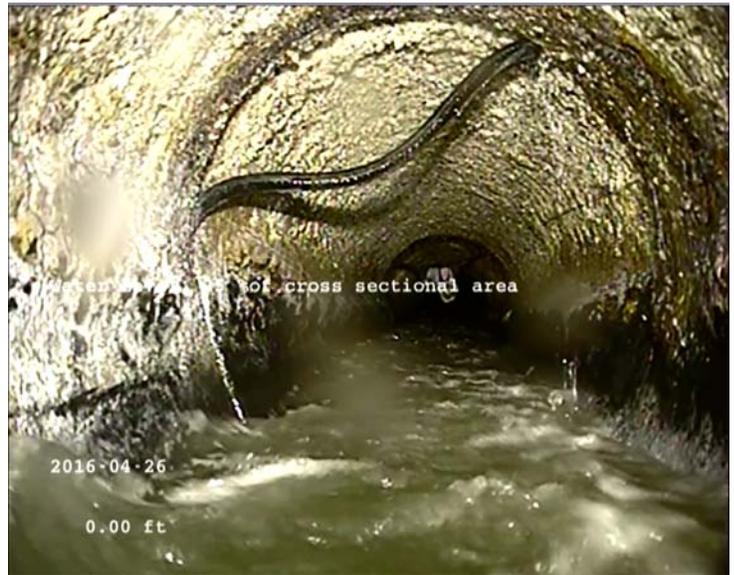
The main sewer interceptor was constructed in the early 1970s. And the concrete in the pipe is susceptible to corrosion from sulfides generated by the wastewater. Over decades, the corrosion has severely deteriorated much of this pipe.

SAW Grant Sewer Video: This photo is from televising the sewer in April 2016 at the location of the emergency repair. It shows the sulfide corrosion on the inside of the concrete sewer interceptor. The thick black item in the center is a rubber gasket between two sections of the concrete pipe; the pipe sections have been corroded away to the point that the gasket is falling in. With the gasket missing, ground water infiltrates the pipe. And the ground water carries grains of sand and sediment. Over time, more sand and more dirt create an empty pocket or void outside the pipe. When this void increases in size, it can collapse causing a sink hole in the road above and breaking the pipe below. The photo also shows a "shelf" on the sides of the pipe where the pipe has corroded above the waterline.

CIPP is a method of adding a plastic liner inside the existing sewer main. It essentially creates a brand new pipe inside the existing pipe. The new pipe provides structural integrity, is resistant to sulfide corrosion, reduces groundwater infiltration, and has an estimated life of seventy-five years. It is installed via existing manholes, so excavation is not needed. As a rule of thumb, CIPP is about half the cost of excavating and replacing a main (and much less expensive than an emergency repair).

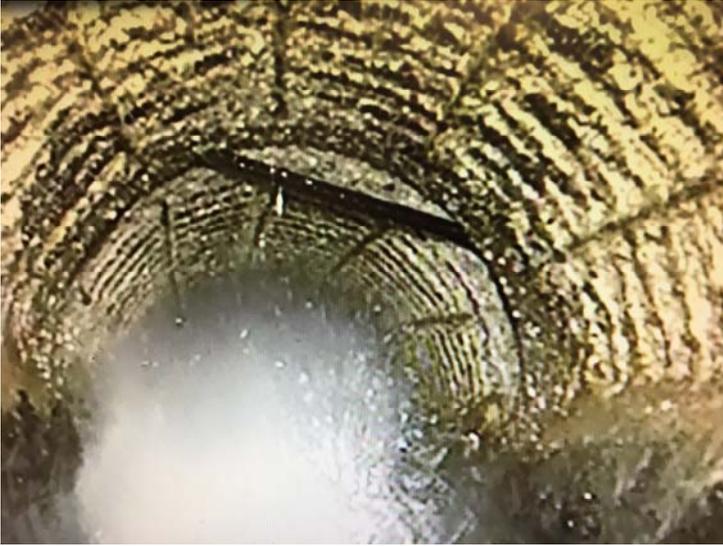
SAW Grant Sewer Video: This photo is from televising the sewer interceptor in April 2016. The grid pattern is the rebar support cage that is built into the concrete pipe. Since it is exposed, it means that the pipe has been corroded half-way through. This photo also shows a gasket beginning to fall out of place between two sections of the concrete pipe and a shelf at the waterline on the sides.
